# TEST REPORT

**Report No. :** SGS-R13-1073

**Product :** One Touch Universal Car Mount

**Model :** HLCRIO102(GP7 & ST4)

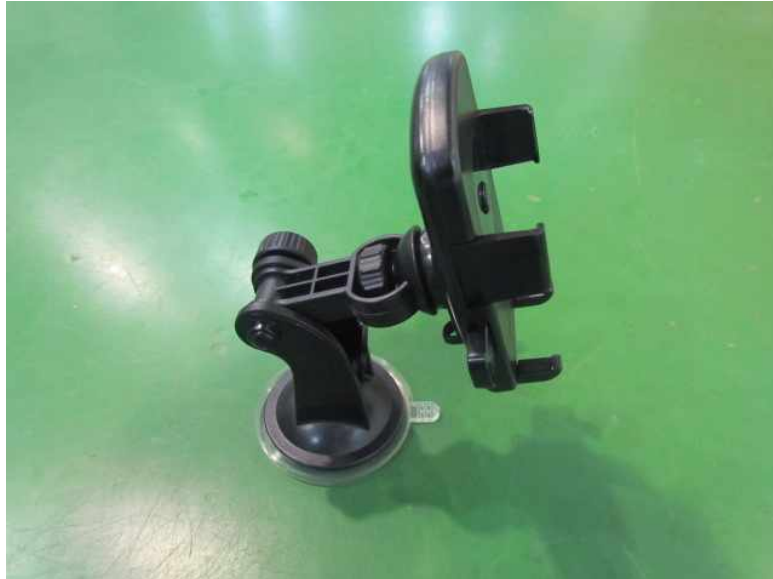
### 2.2 Photograph

Applicant : iOttie. Inc.  
Manufacturer : HSM Co., Ltd.  
Product : One Touch Universal Car Mount  
Model : HLCRIO102(GP7 & ST4)  
Serial number : N/A

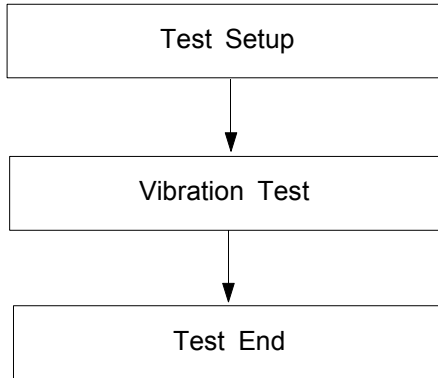
### 3. Test Process

- 1) Perform a visual inspection and an operational check for the specimen.
- 2) Fix the specimen on the vibration table.
- 3) Operate the vibration tester.
- 4) Repeat from steps 2) to step 3) for each required axis.
- 5) Perform a final visual inspection and an operational check for the specimen.

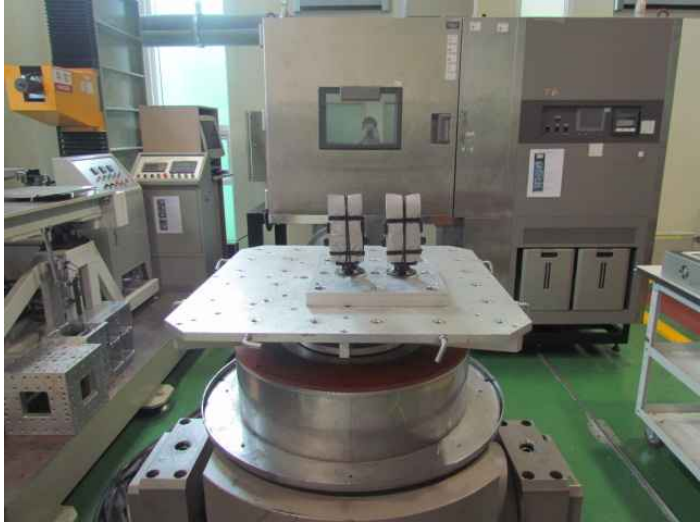
Test axis	Test photograph
Vertical (Z)

- 1) Test type : Random
- 2) Frequency : (5 ~ 200) Hz
- 3) Acceleration : 19.992 m/s<sup>2</sup> r.m.s (2.04 g<sub>n</sub> r.m.s)
- 4) Test time : Total 3 h (1 h in each axis)
- 5) Test axis : Vertical (Z), Transverse (X), Longitudinal (Y)
- 6) Sample state : Unpackaged product / Non-operation
- 7) Check time : After the test
- 8) Sample quantity : 2 EA
- 9) Load weight : 200 g
